A Red Light Running (RLR) Photo Enforcement System was installed at the intersection of IL 83 and Riverside Drive on February 28, 2009, after finding limited success with other attempted measures to promote safer driving and improve compliance with traffic laws. As a condition of use, both Illinois law and the Illinois Department of Transportation require periodic statistical analyses / evaluations be conducted.

IL 83 & Riverside Dr. Villa Park, IL

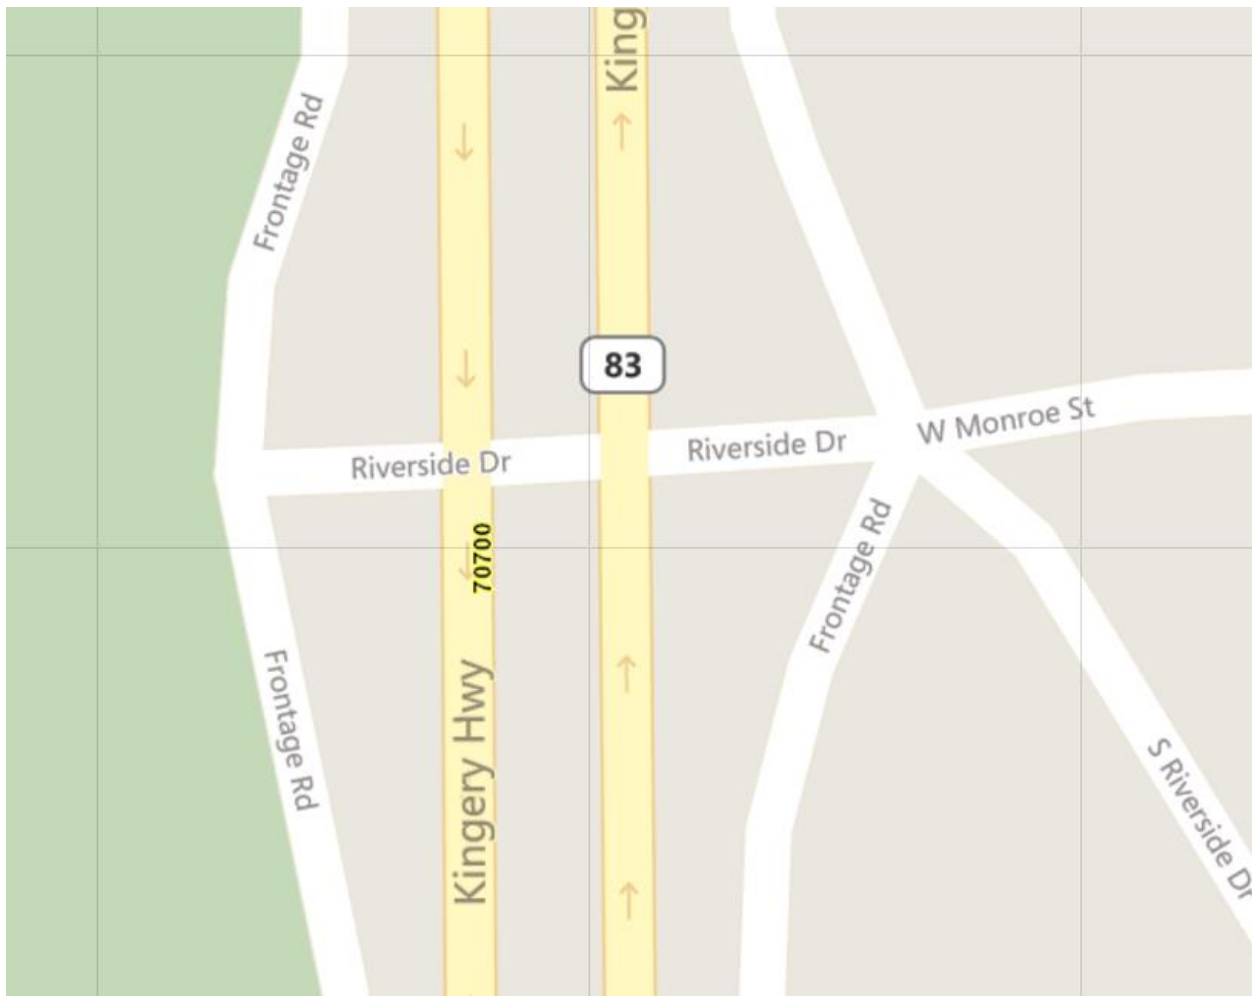
IL 83 & Riverside Dr. (Eastbound/Westbound)

- No historical traffic data available
