A Red Light Running (RLR) Photo Enforcement System was installed at the intersection of Roosevelt Road (IL 38) and Summit Avenue on March 27, 2009, after finding limited success with other attempted measures to promote safer driving and improve compliance with traffic laws. As a condition of use, both Illinois law and the Illinois Department of Transportation require periodic statistical analyses / evaluations be conducted.

Roosevelt Rd. & Summit Ave.

Villa Park, IL

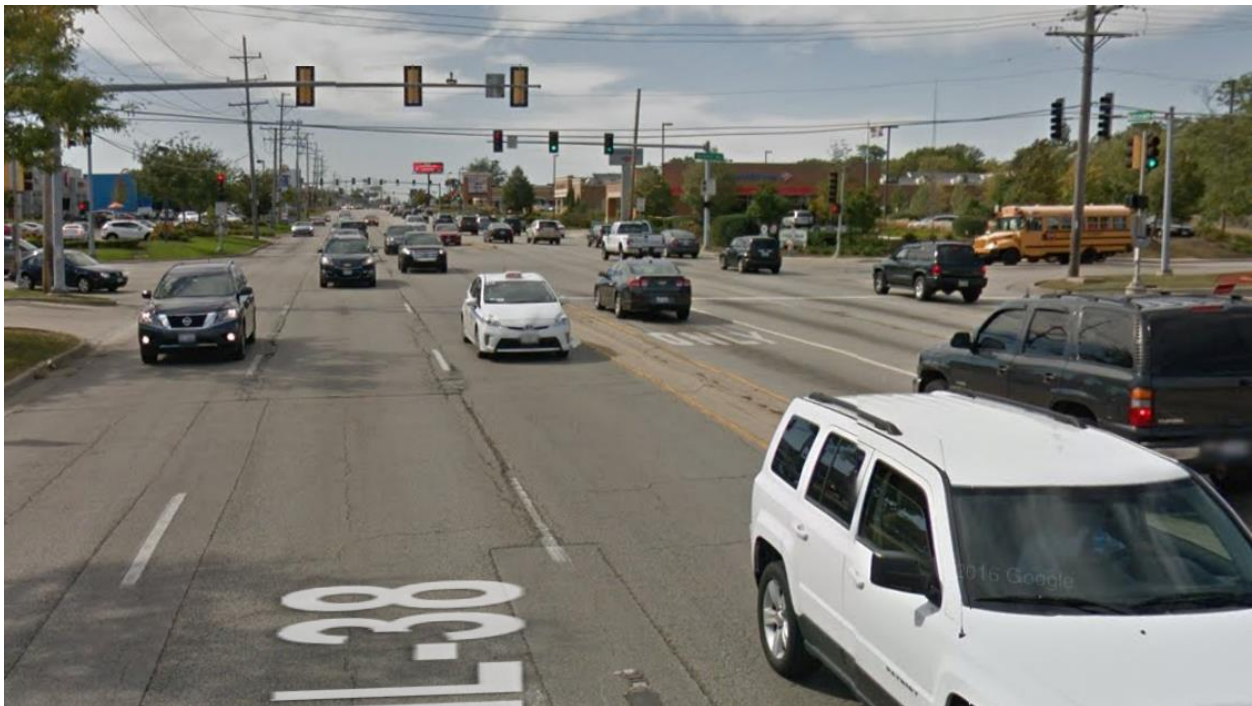
Roosevelt Rd. & Summit Ave. - Westbound Approach

- RLR Photo Enforcement System monitors violations occurring on the westbound approach of the intersection
- RLR Photo Enforcement System installed: March 27, 2009
- Traffic signal timing strictly adheres to the guidelines for timing of clearances established by the Illinois Department of Transportation (IDOT), in accordance with the MUTCD standards. Neither the Vendor nor the Village has access to or influence over the establishment of signal timings. Both entities understand that tampering with these timings would be a safety violation with significant consequences.
